**P/V Northern Victor
Udagak Bay
Unalaska Island, Alaska
June 2008
Dive Survey**

By Magone Marine Service, Inc.

M/V Northern Victor – NPDES Permit # AK-005286-8
Udagak Bay
Unalaska Island, AK
Latitude: 53° 44.062'
Longitude: 166° 19.476'

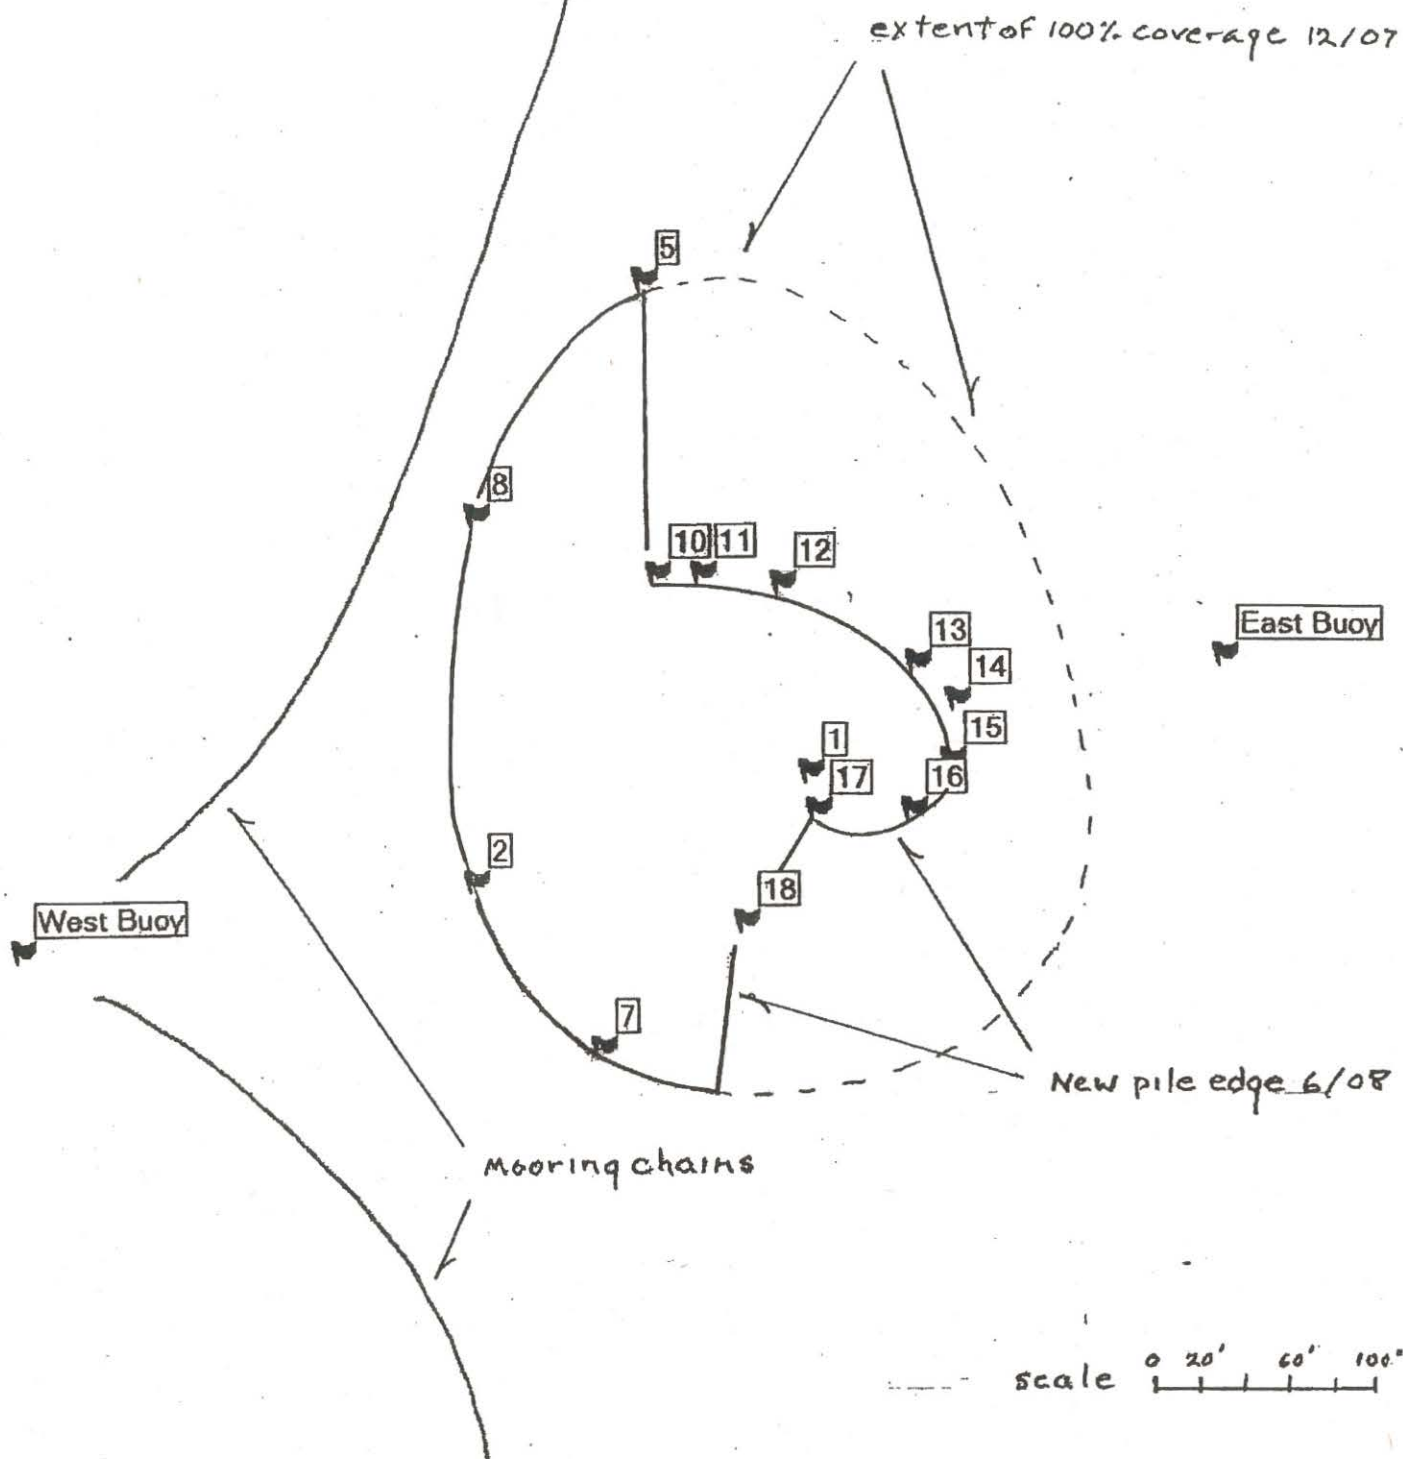
See Map – page 9

Scaled diagram of Deposit showing former Pile "B" perimeter.

Northern Victor "Pile #3"
Dive Survey results
Following plowing operation 06/08

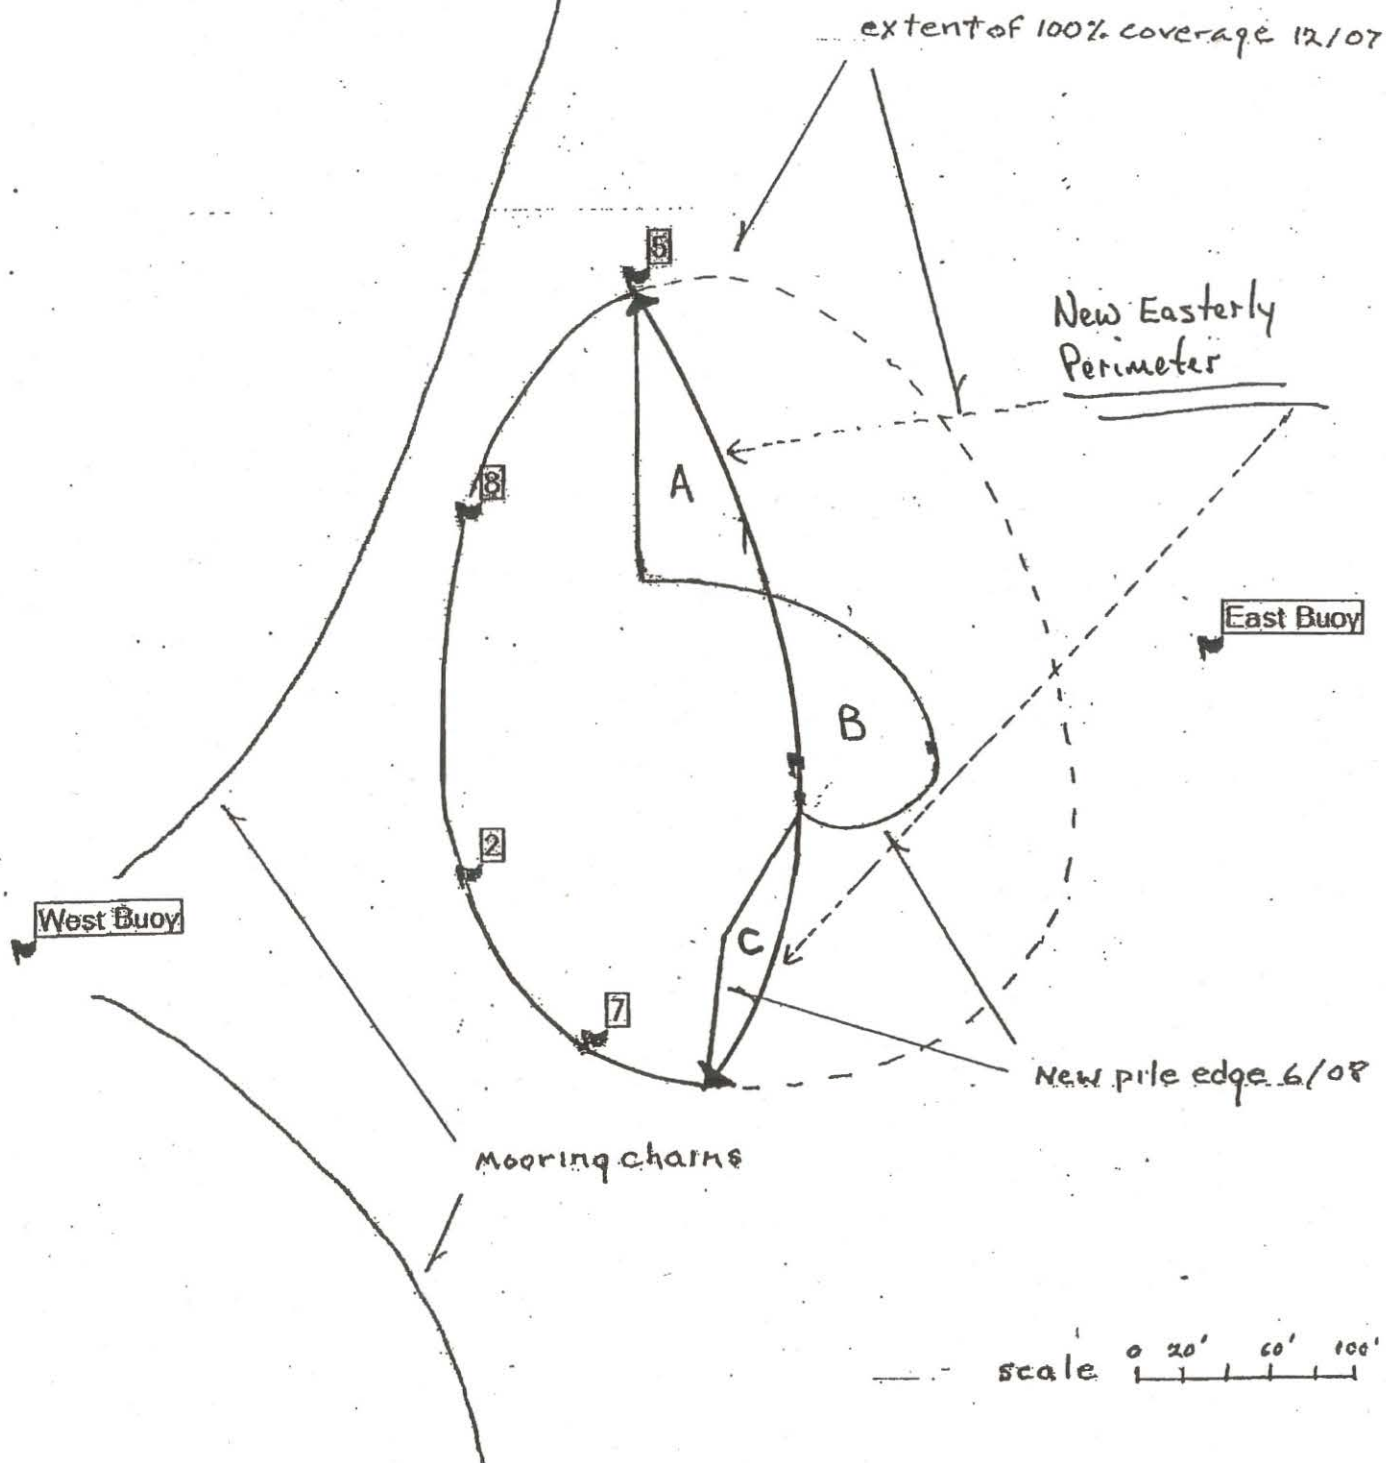
See Map – page 10

The irregular shape of the new pile B footprint was not conducive to simple area calculations without modifications as shown on page 10. Modifications consisted of drawing an arc connecting the north and south ends of the pile. This line becomes the new *virtual* easterly perimeter and creates three irregular shapes A, B and C. Shapes A and C though not part of the new pile as shown on page 9, are now assumed to be part of the modified drawing of the pile on page 10 and B is assumed to be excluded from the modified drawing of the pile. The justification for inclusion of A and C and exclusion of B is that Area (A) + Area (C) is greater than or equal to Area (B). In other words we have included more area than we excluded. Agreeing with that premise allows redrawing the pile in a shape that easily lends itself to an area calculation.

Scaled diagram of Deposit with Perimeter redrawn to facilitate estimation of area.

Northern Victor "Pine pile #3"
Dive Survey result.
Following plowing operation 06/08
